Information System for Preventing Rail Collisions for D3 Line

SHERLOG D3 R UNIT TEST PROTOCOL 2022

SHERLOG D3 R USE CASE

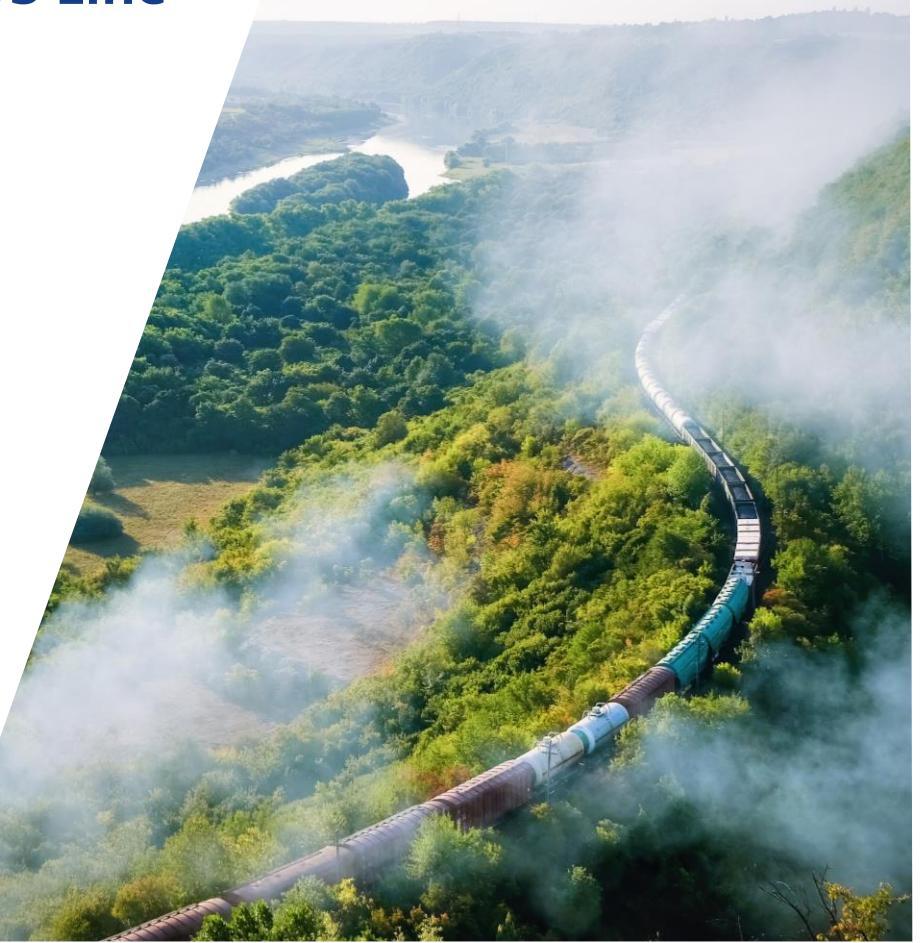
- The SHERLOG SHG D3R Information System for Rail Vehicle Safety (hereinafter "SHG D3R") comprises communication units with GPS, VHF (optionally also with a supplementary GSM unit) and a display unit—touchscreen display.
- A SHERLOG SHG D3R module will be located in every rail vehicle on D3 lines. Thanks to the SHG D3R system, rail vehicle operators' attention is drawn to other rail vehicles nearby. The display shows other rail vehicles identified with their designation, distance and direction (depending on the terrain on the order of kilometres).
- The SHERLOG SHG D3R Information System for Rail Vehicle Safety therefore ensures preventative measures and prevents collisions by rail vehicles on D3 lines. The SHG D3R informs and notifies rail vehicle operators of possible dangers optically and acoustically a long time in advance.

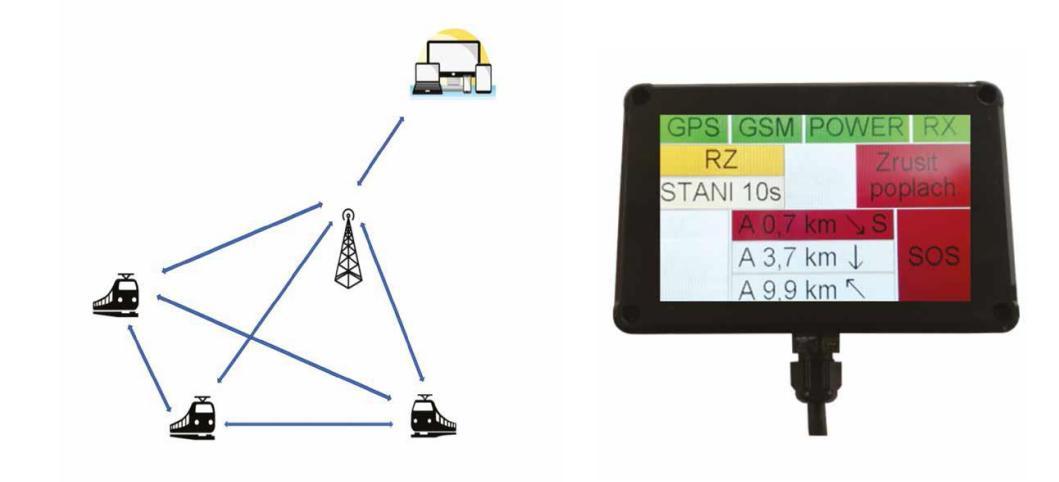
- Mobile unit
- Rail vehicle identification data input into unit
- Optional RFID reader for train driver identification
- Optional connection of unit to other rail vehicle systems— USB series ports, RS-232, RS-485 for transmission of relevant data
- High-precision localisation of rail vehicle on track using GNSS satellite system (optionally GPS, Galileo, Glonass)
- Optional gravitation sensors for impact detection

- Connection to power supply in rail vehicle, 230 V or USB connector
- Installation of unit holder in driver's cab

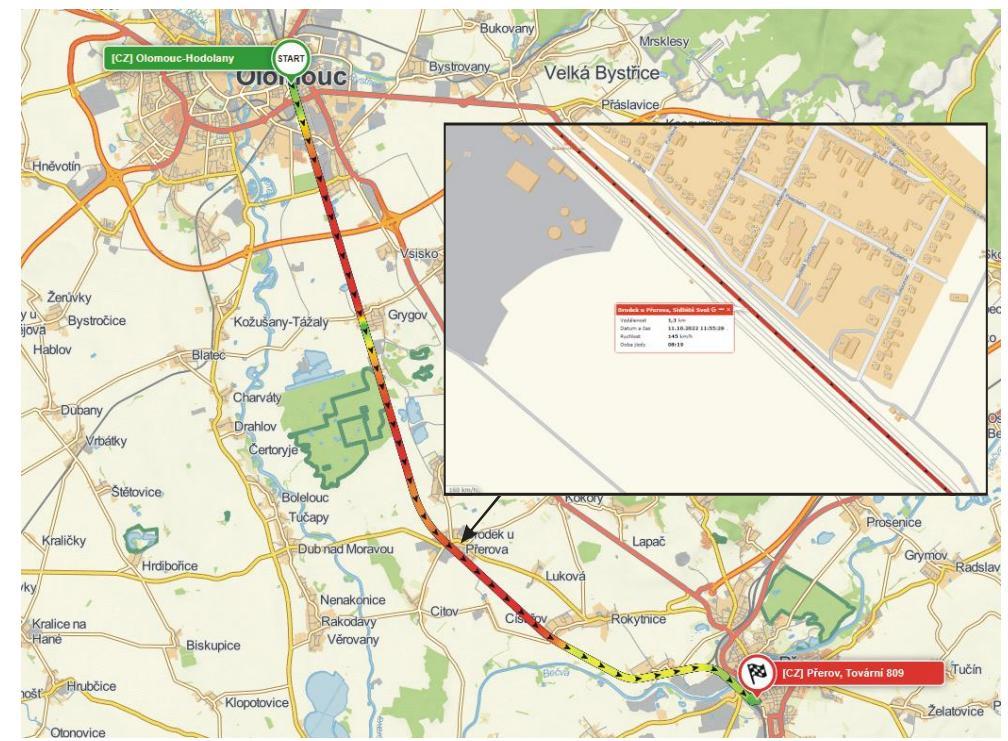
Olomouc - Přerov track, locomotive VECTRON

Test C - Test of accurate GPS receiver. For this functionality it is necessary to calibrate the GPS receiver after switching on the unit. The unit and the GNSS antenna were always in the driver's cab. The position, in addition to being visualised on the tablet on the map base, was also recorded in memory for subsequent analysis.

All the tests went well and met the expectations. The GPS unit worked with an accuracy of <60cm, and never once showed a larger deviation. The GPS unit also worked reliably in the Vectron locomotive, which is considered to be the most shielded motive power vehicle at ČD. The GSP unit used ONLY the native GNSS satellite signal, without GSM/GPRS correction.

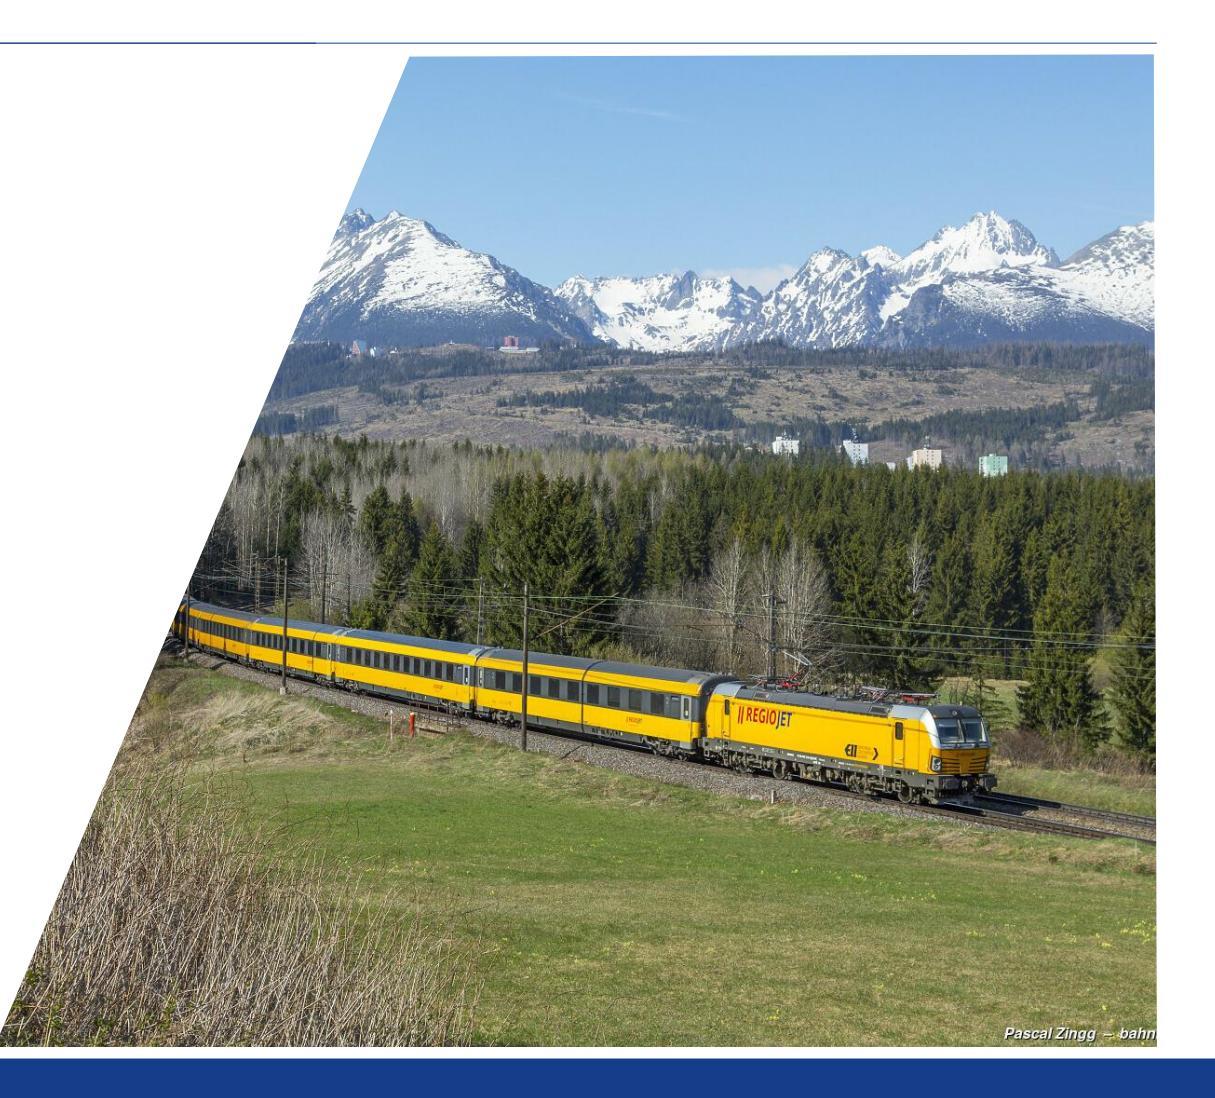
- To ensure the safety of railway vehicles our company has developed the SHERLOG D3 R informative system. This consists of communication units using GNSS and VHF technology, and displays located in every railway traction vehicle and self-propelled vehicles.
- The principle is simple the system alerts the train driver of any other train in the vicinity (either approaching or going in the same direction) – thanks to the information provided by this system, the train driver will have plenty of time to assess the situation and possibly stop the train or communicate with the track dispatcher. The system safely functions via VHF radio communications, surrounding units communicate directly between each other. Functionality does not require any GSM signal or connection with the dispatcher.

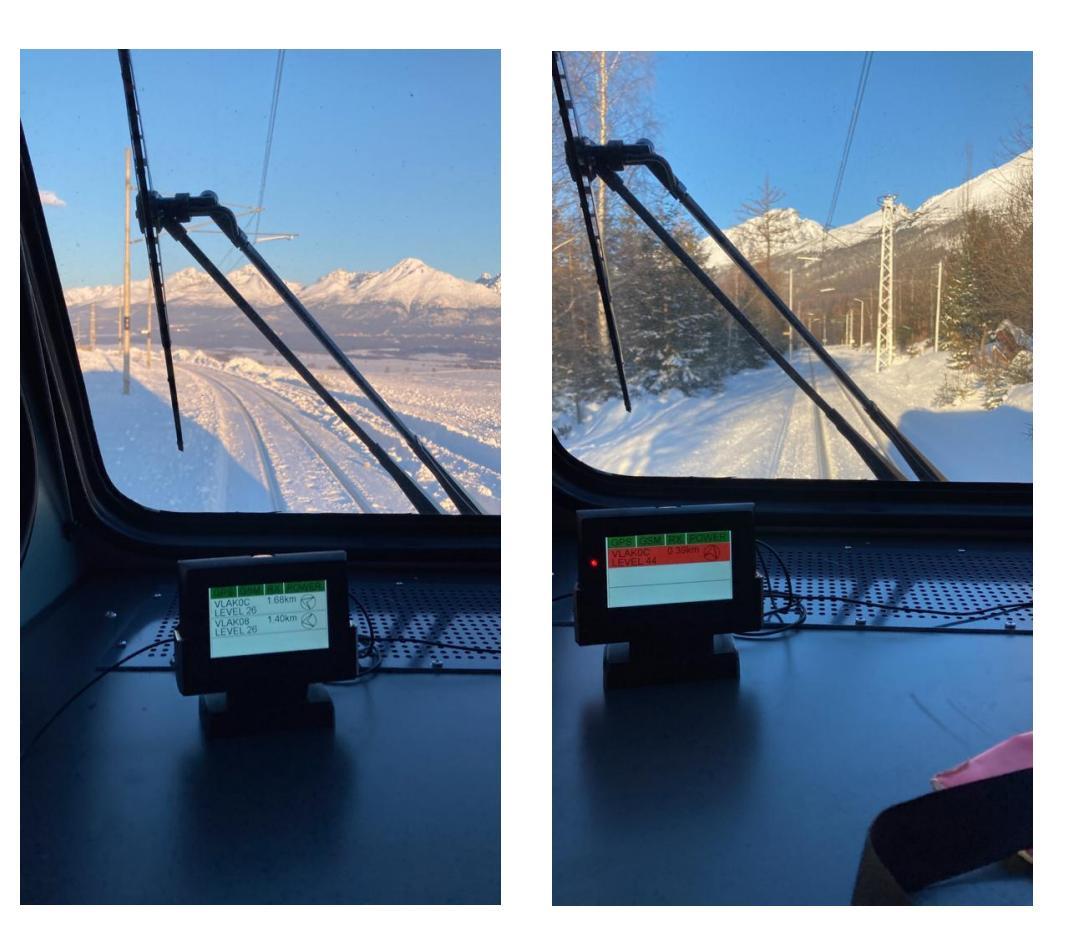
Installation in railway vehicles is very fast and simple. It takes no more than 1 hour to install the docking station for the D3R unit. The D3R unit itself is userportable. The unit does not require any data from the railway vehicle, just the train or connection number entered by the driver before the start of the journey.
